Appendix C. Stream Restoration Concept Sheets

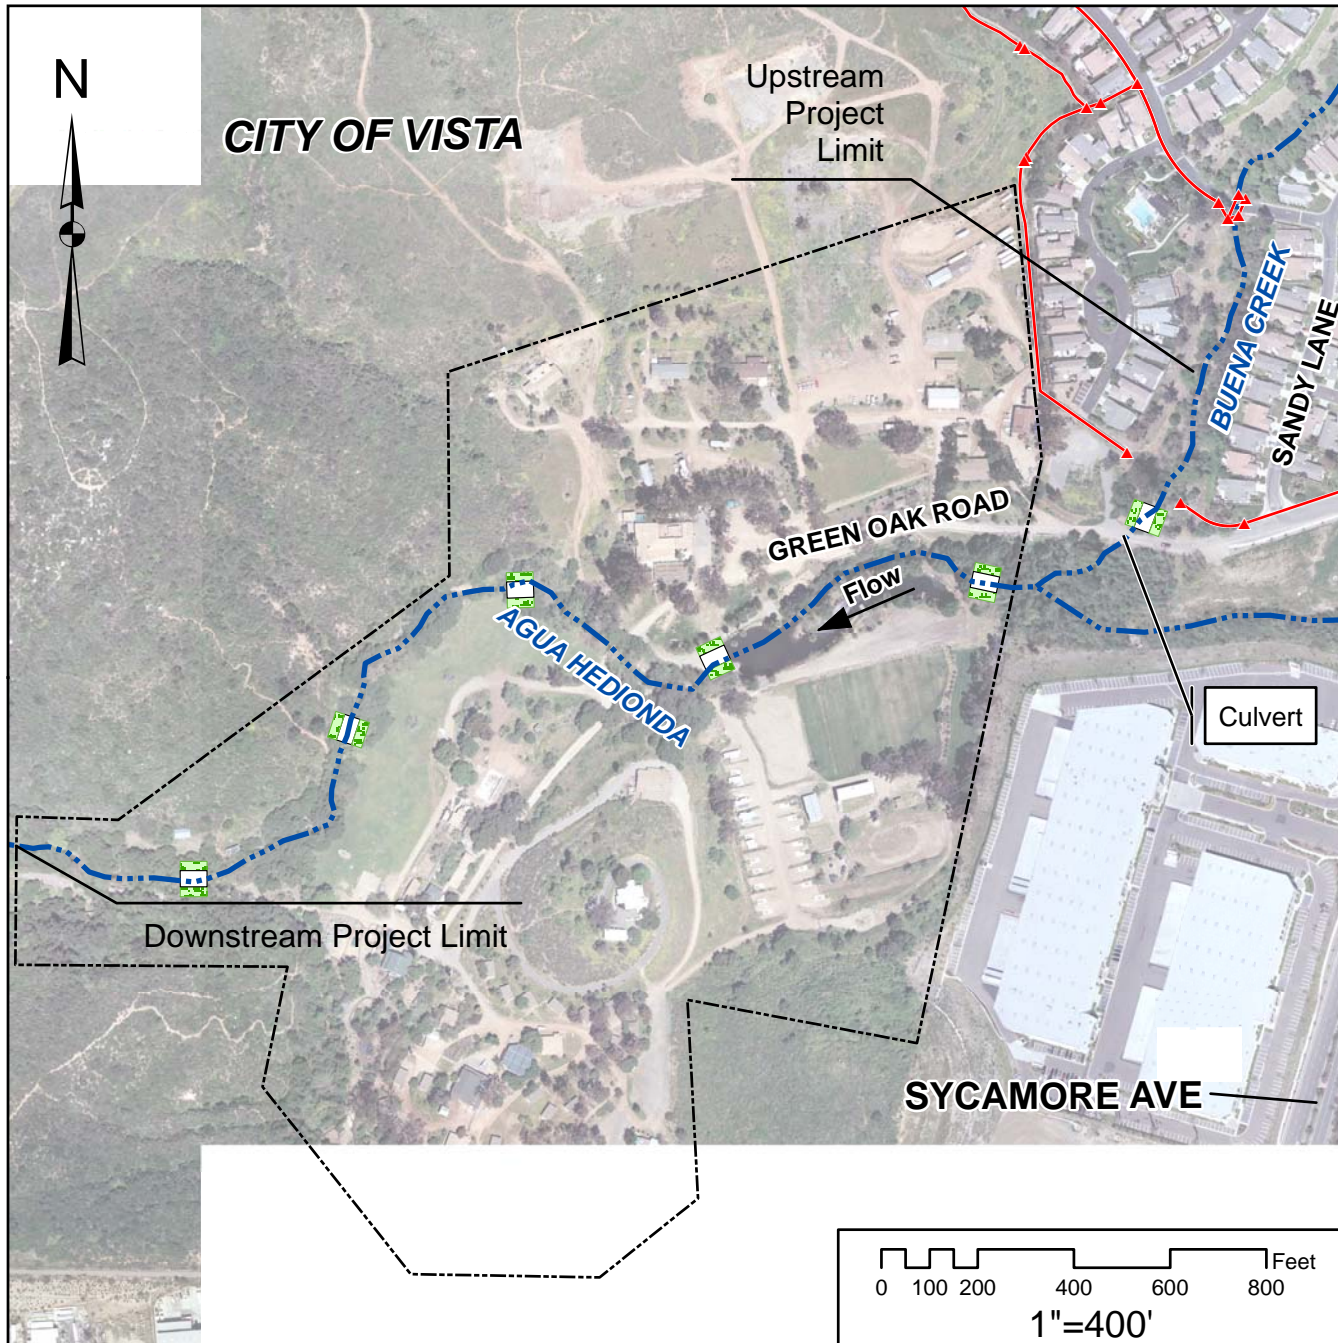
Site #SR-1: Agua Hedionda Reach 9

- Clogged culvert
- Obstructed culvert entrance
- Bank erosion

- Clean culvert
- Regrade culvert entrance area
- Grade Stabilizers

- Low profile (up to 2' drops)
- Select locations that do not disturb high value trees

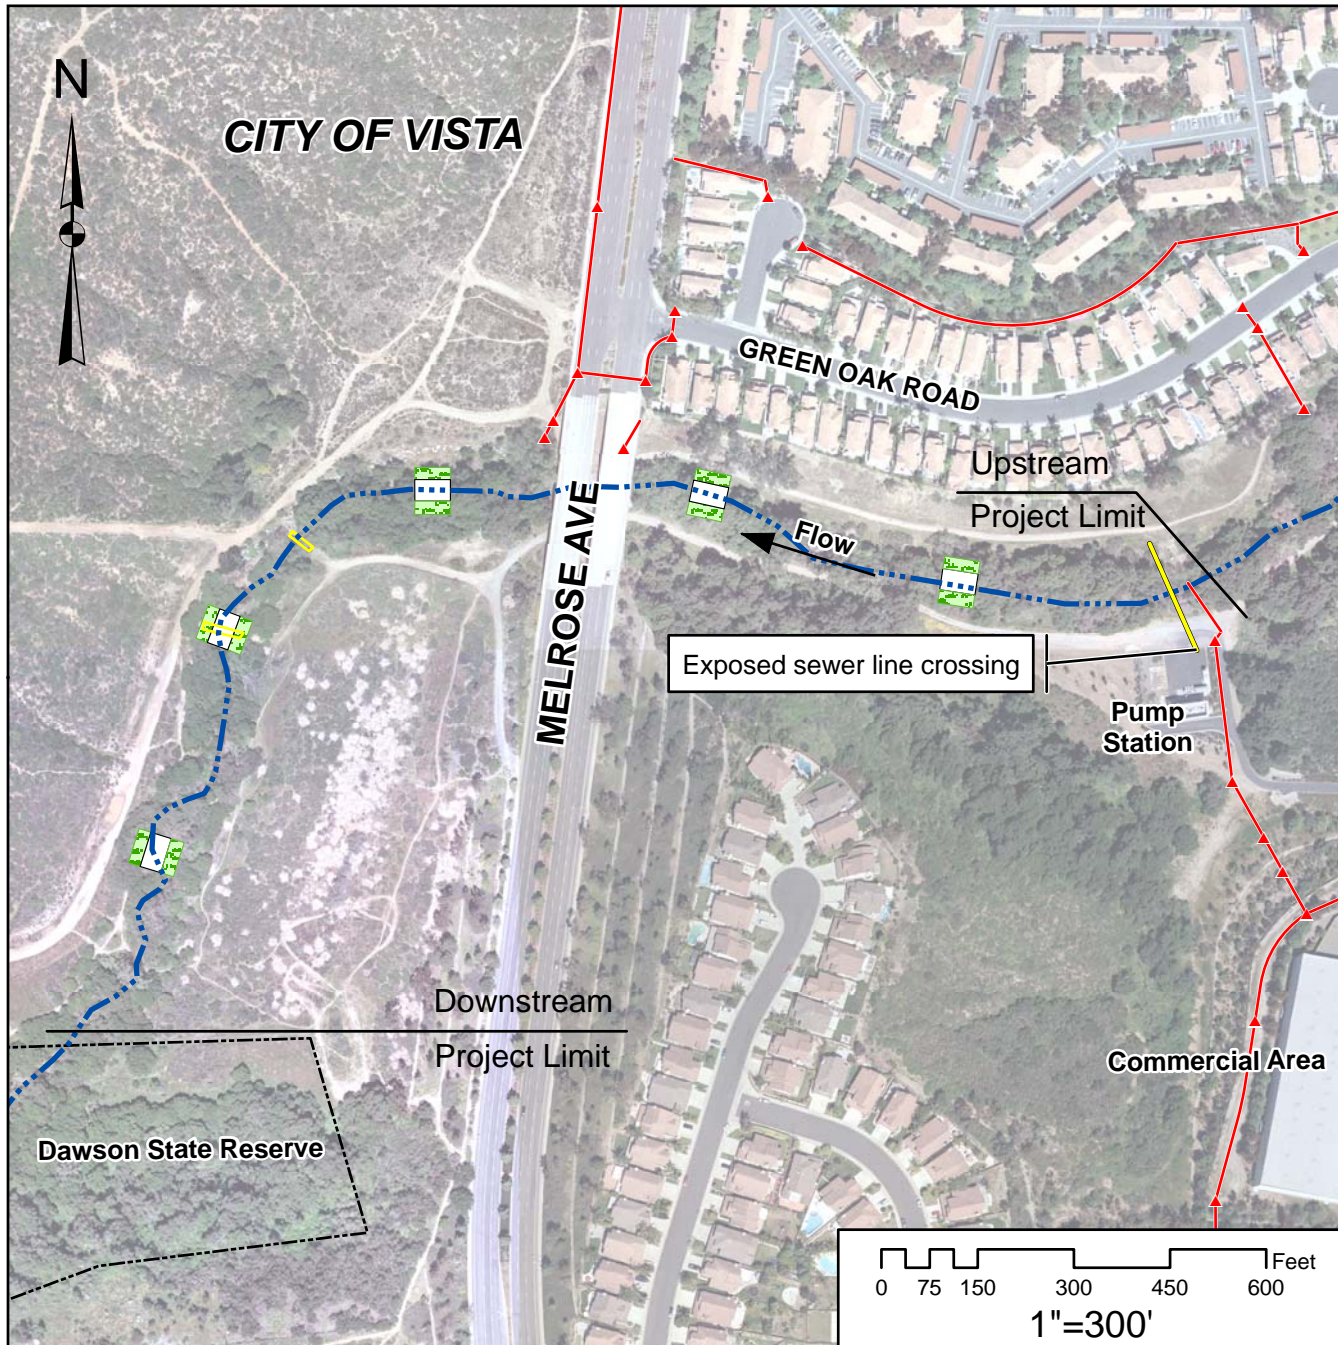
Site #SR-2: Agua Hedionda Reach 14-15

- Erosion along the toe
- Large trees undercut
- Exposed sewer line
- Failing Grade Stabilizer

Grade Stabilizers

- Low profile (up to 2' drops)
- Select locations that do not disturb high value trees

Toe Protection

- At location of imminent failure
- Soil wraps, boulders, rock vanes, willow whips

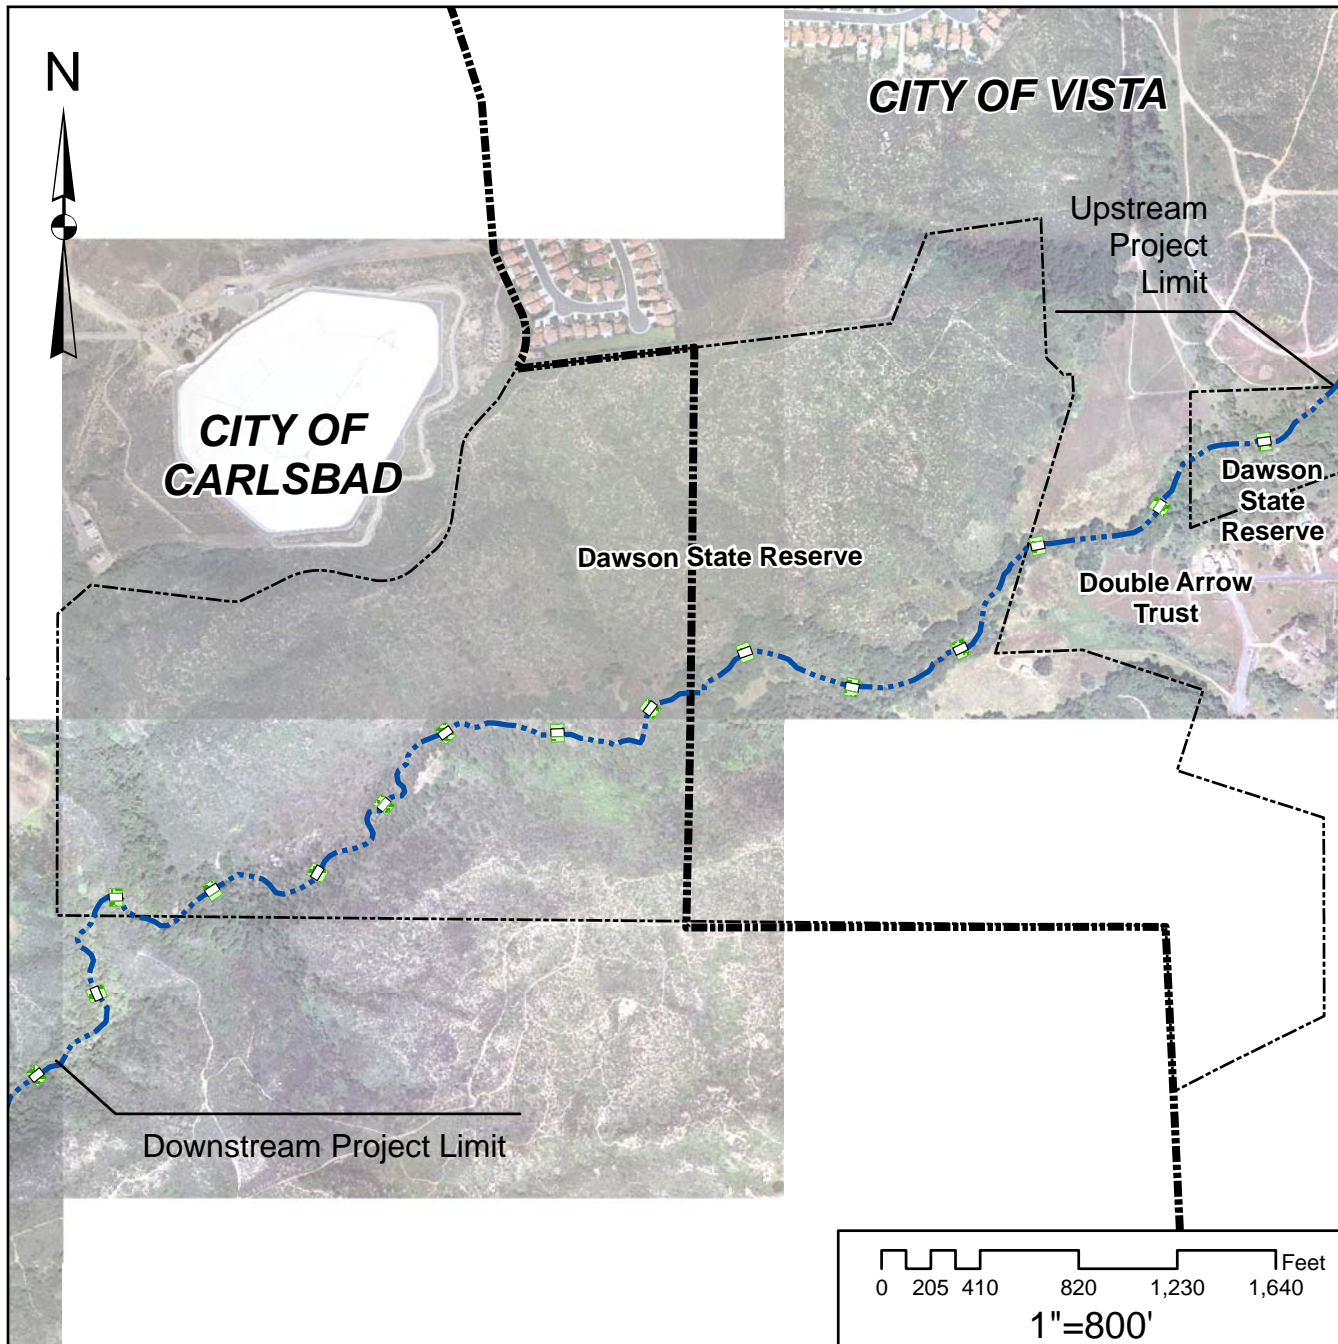
Site #SR-3: Agua Hedionda Reach 17

Moderate to significant bank failure at specific locations

Identification of bedrock controls
Determine if bedrocks allows for significant additional bank failure

Toe Protection (rock) at select locations

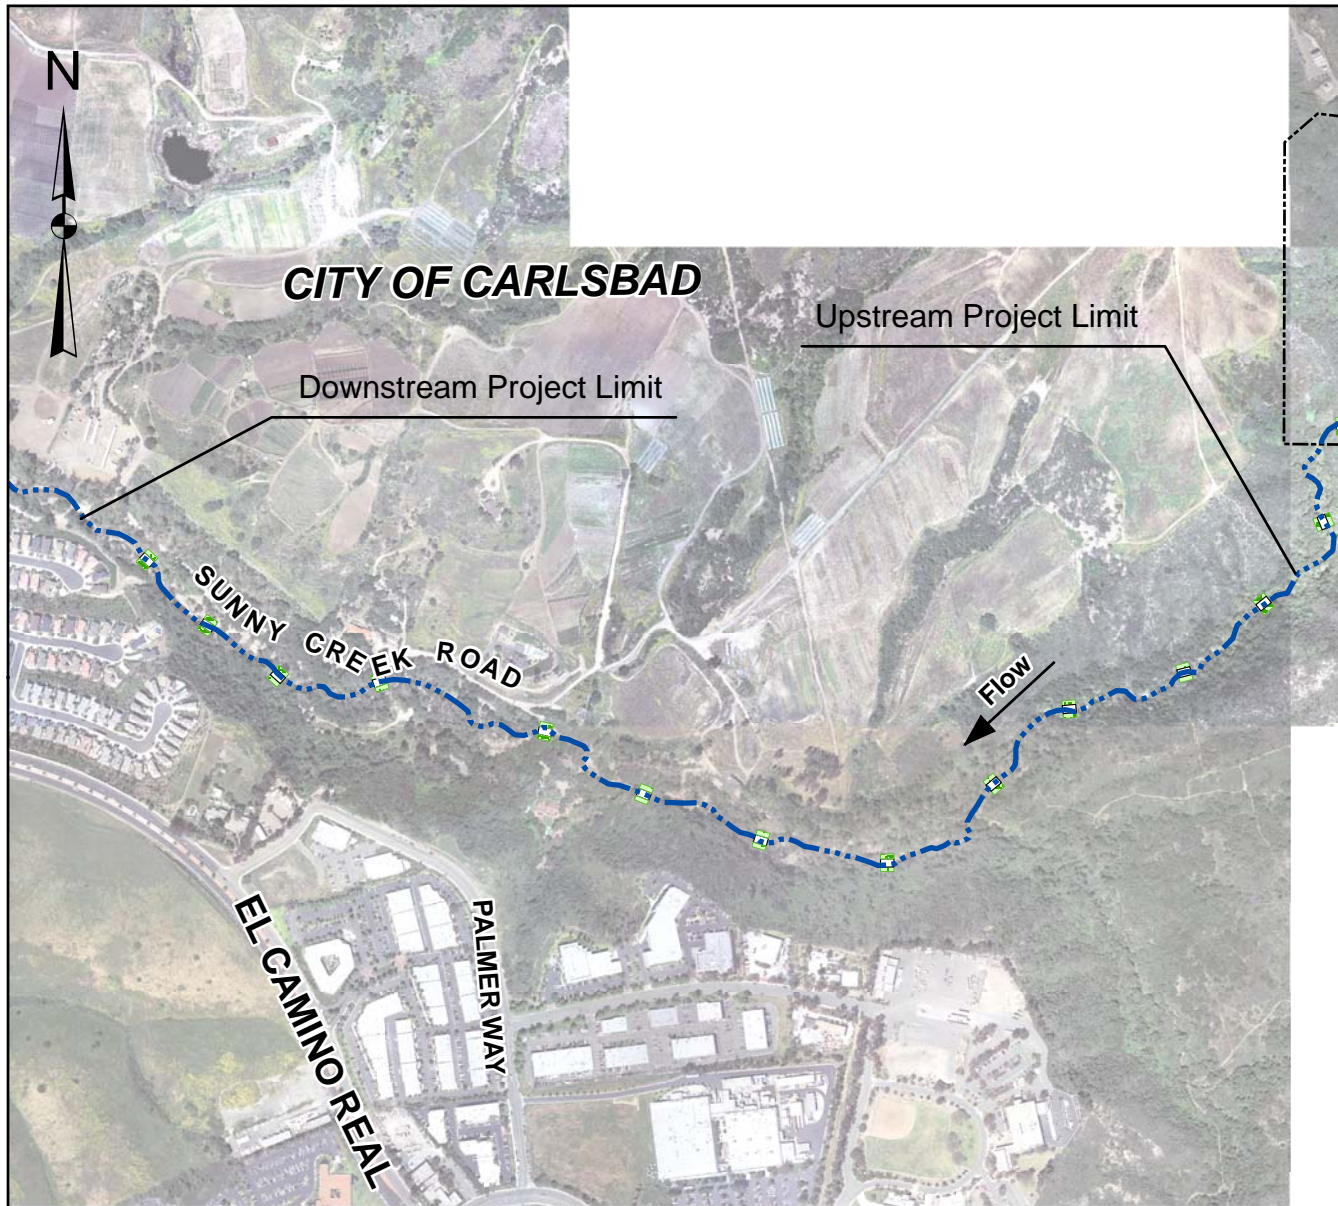
Site #SR-4: Agua Hedionda Reach 18

Moderate to significant bank failure at specific locations

Identification of bedrock controls
Determine if bedrocks allows for significant additional bank failure

Toe Protection (rock) at select locations

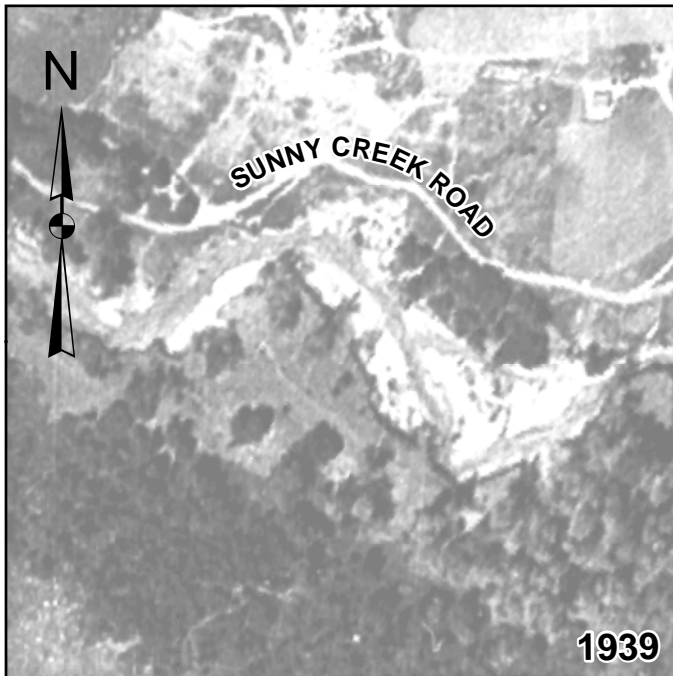
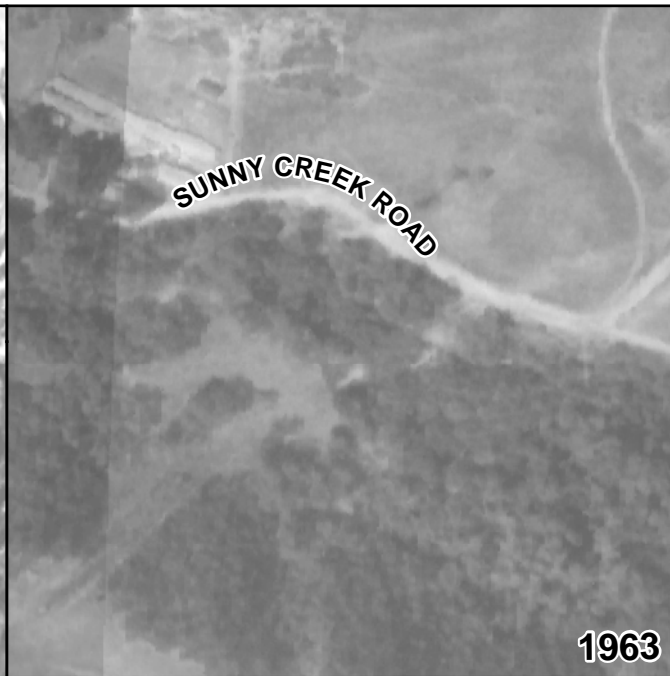
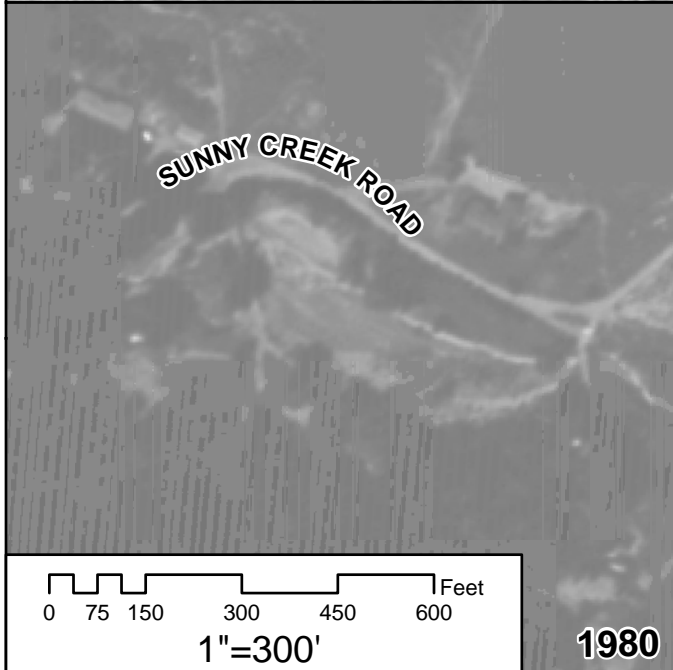
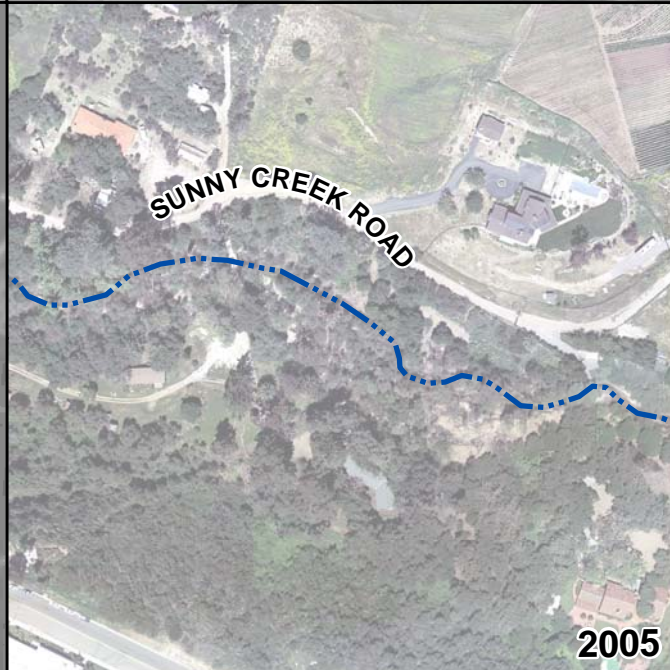
Site #SR-5: Agua Hedionda, Oak Lake

Major Issues
Habitat Feature

Restoration Opportunities
Restore Habitat Feature

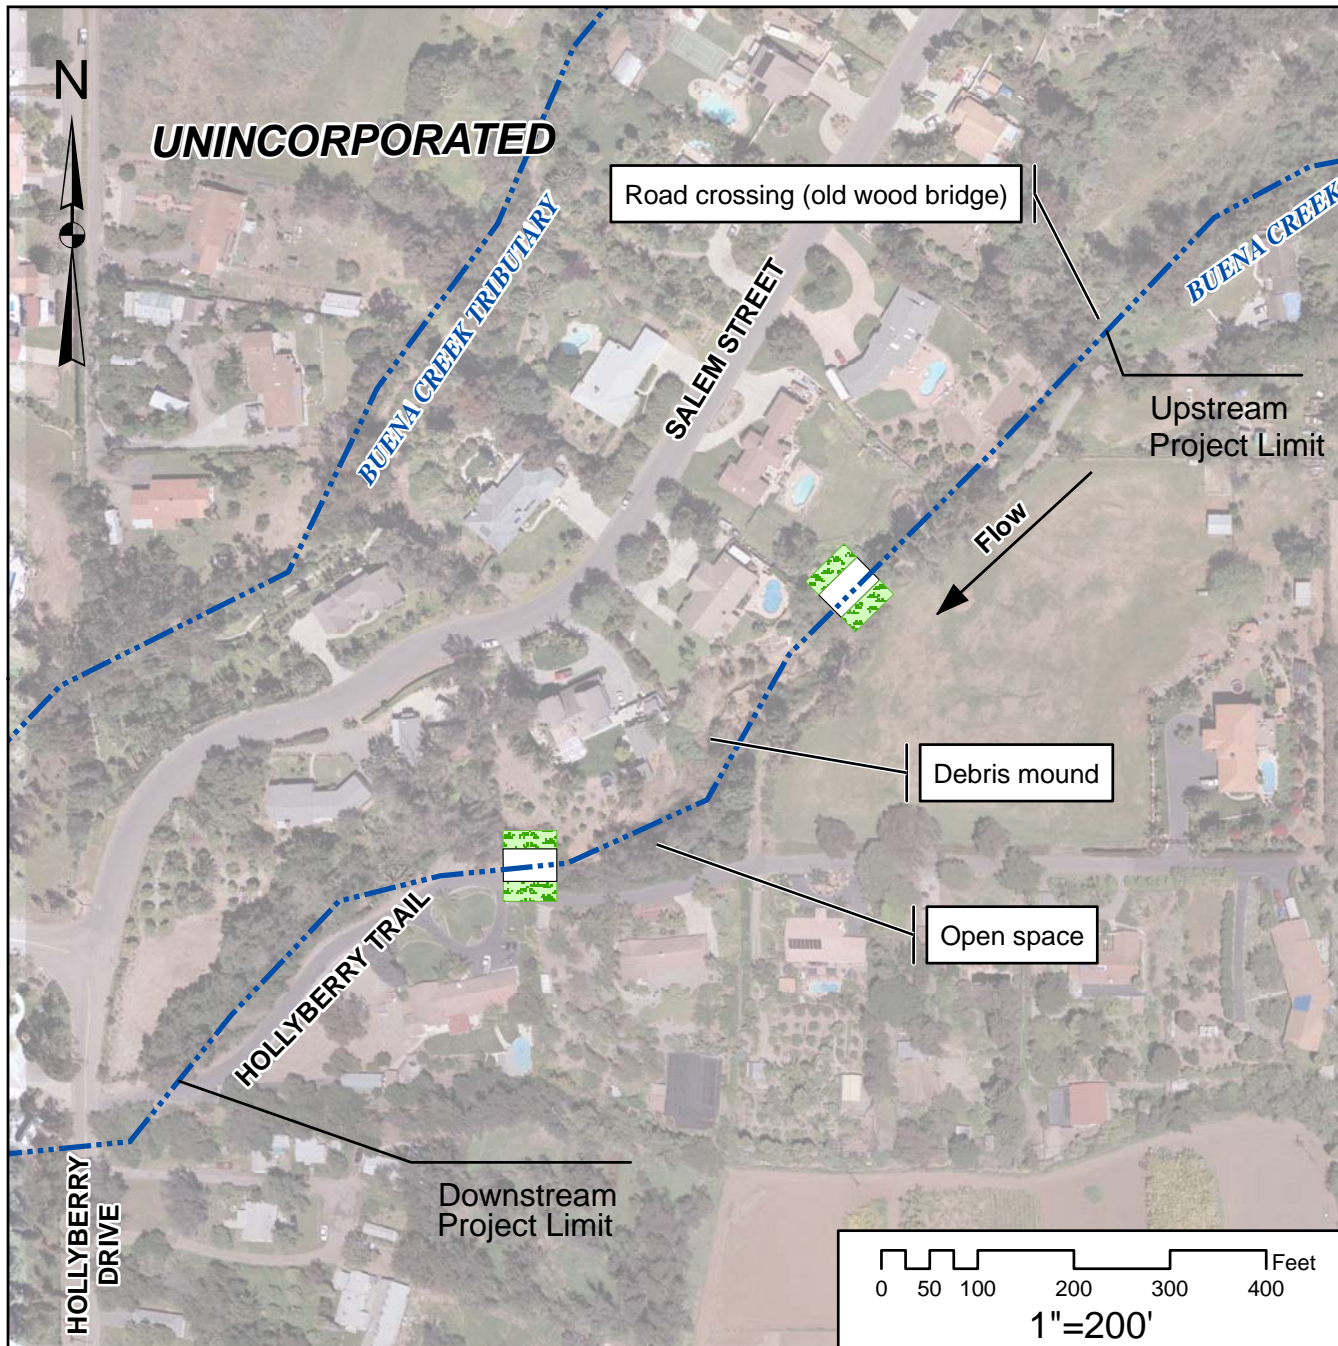
Site #SR-6: Buena Creek Reach 23

- Intermittent bank protection
- Bank erosion to 6' high
- Channel clogged with debris

Grade stabilizers

- Use rock to match natural setting
- Create riffles to mimic existing conditions

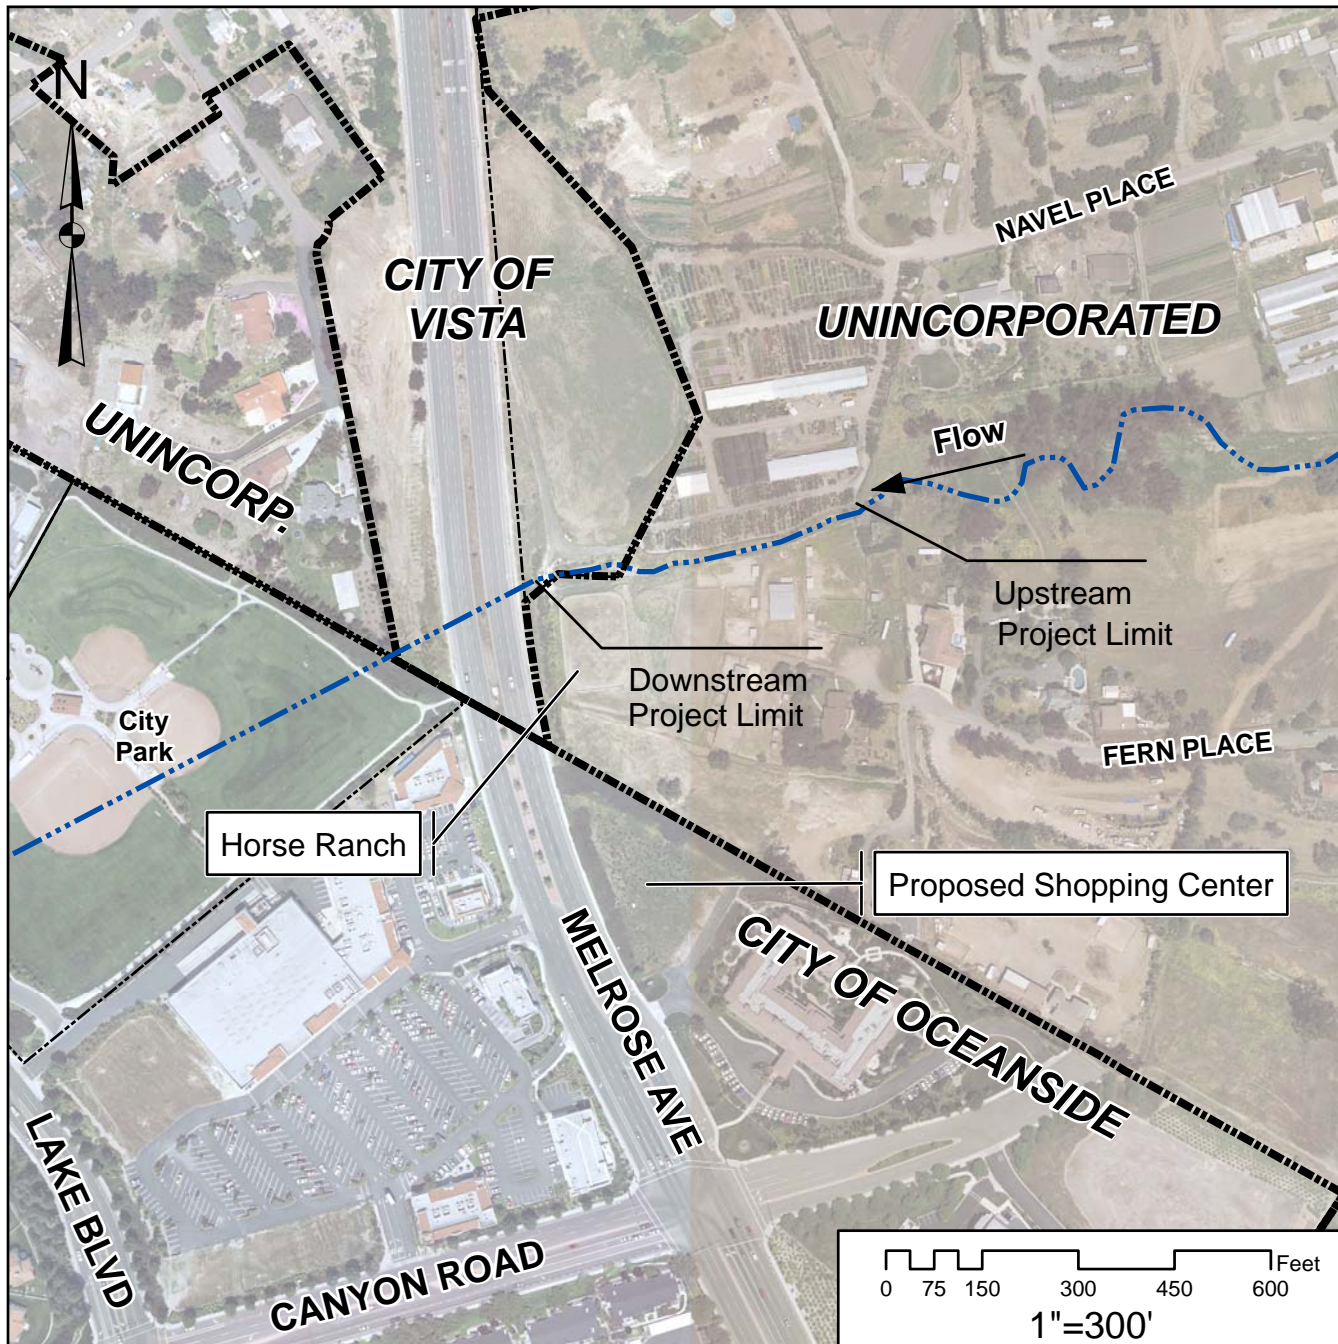
Site #SR-7: Calavera Creek Reach 51

- Channel severely restricted
- No riparian area
- Likely water quality impact from adjacent agriculture

- Purchase adjacent land
 - Widen channel
 - Establish Riparian buffer
- Educational Opportunities
 - Connect proposed shopping center to river

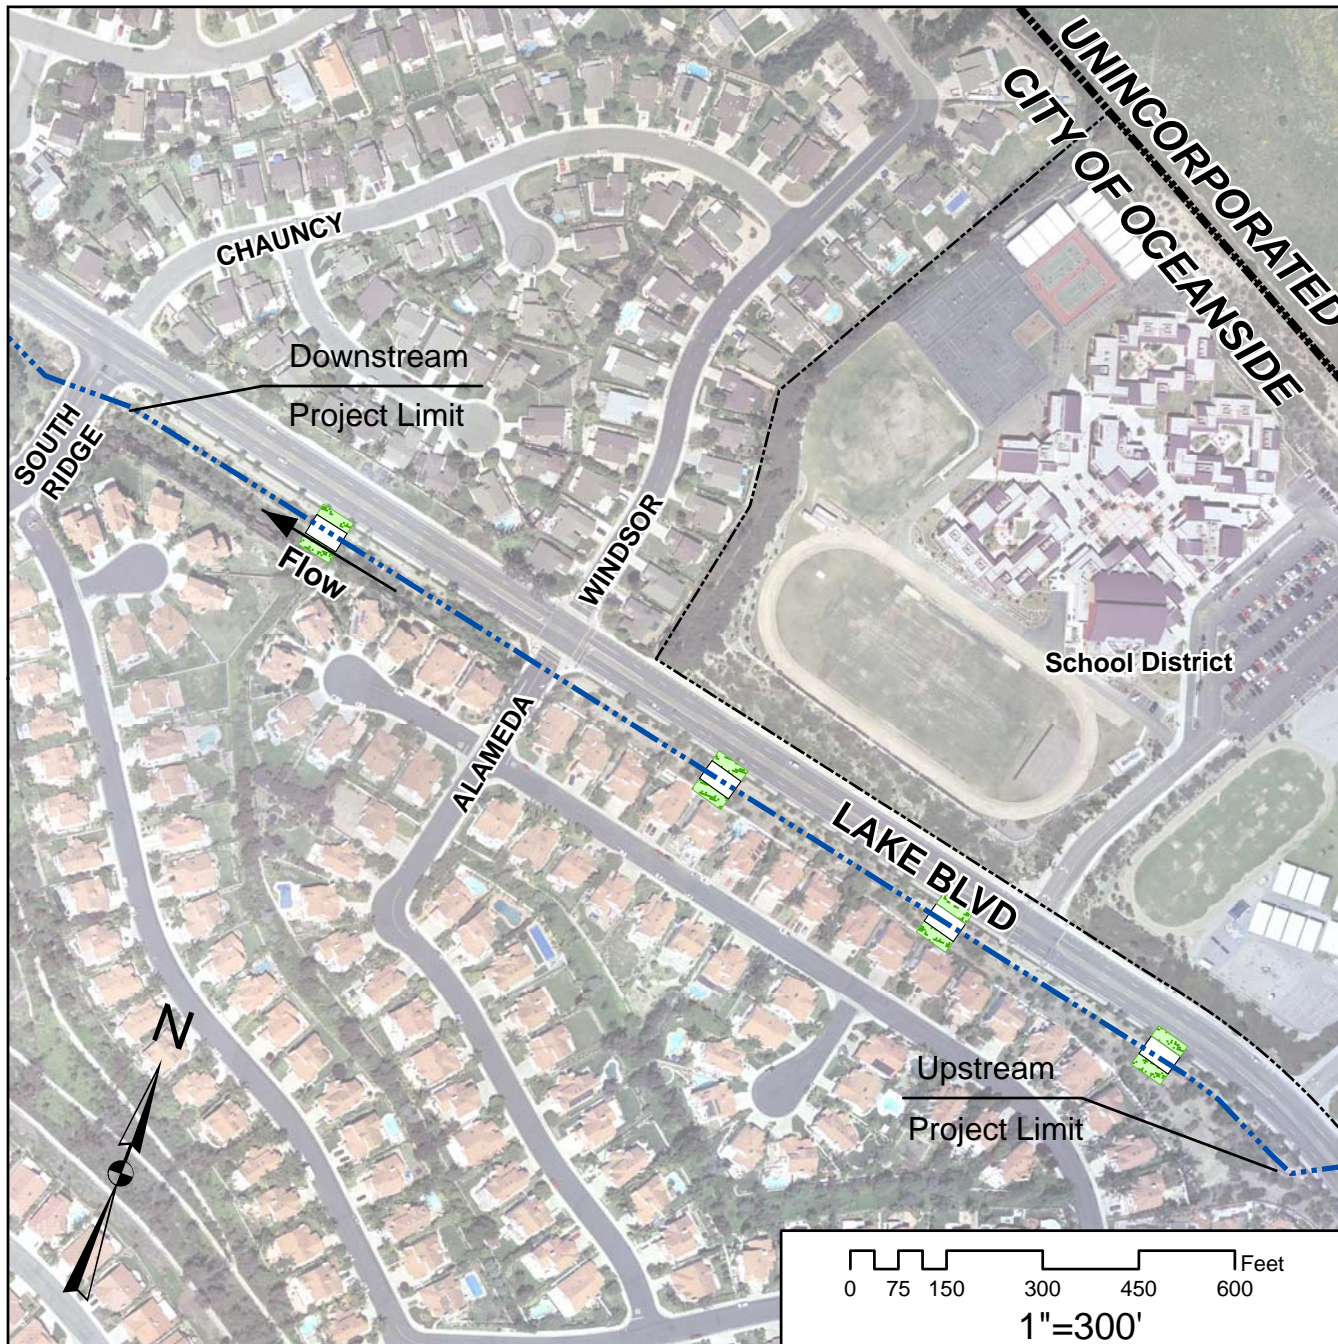
Site #SR-8: Calavera Creek Reach 56A

- Erosion along the toe
- Widening Channel
- Adjacent infrastructure (road and property wall)
- Failed grade stabilizers (sand bags)

Grade Stabilizers

- Low profile (up to 2' drops)
- Use rock to match natural settings

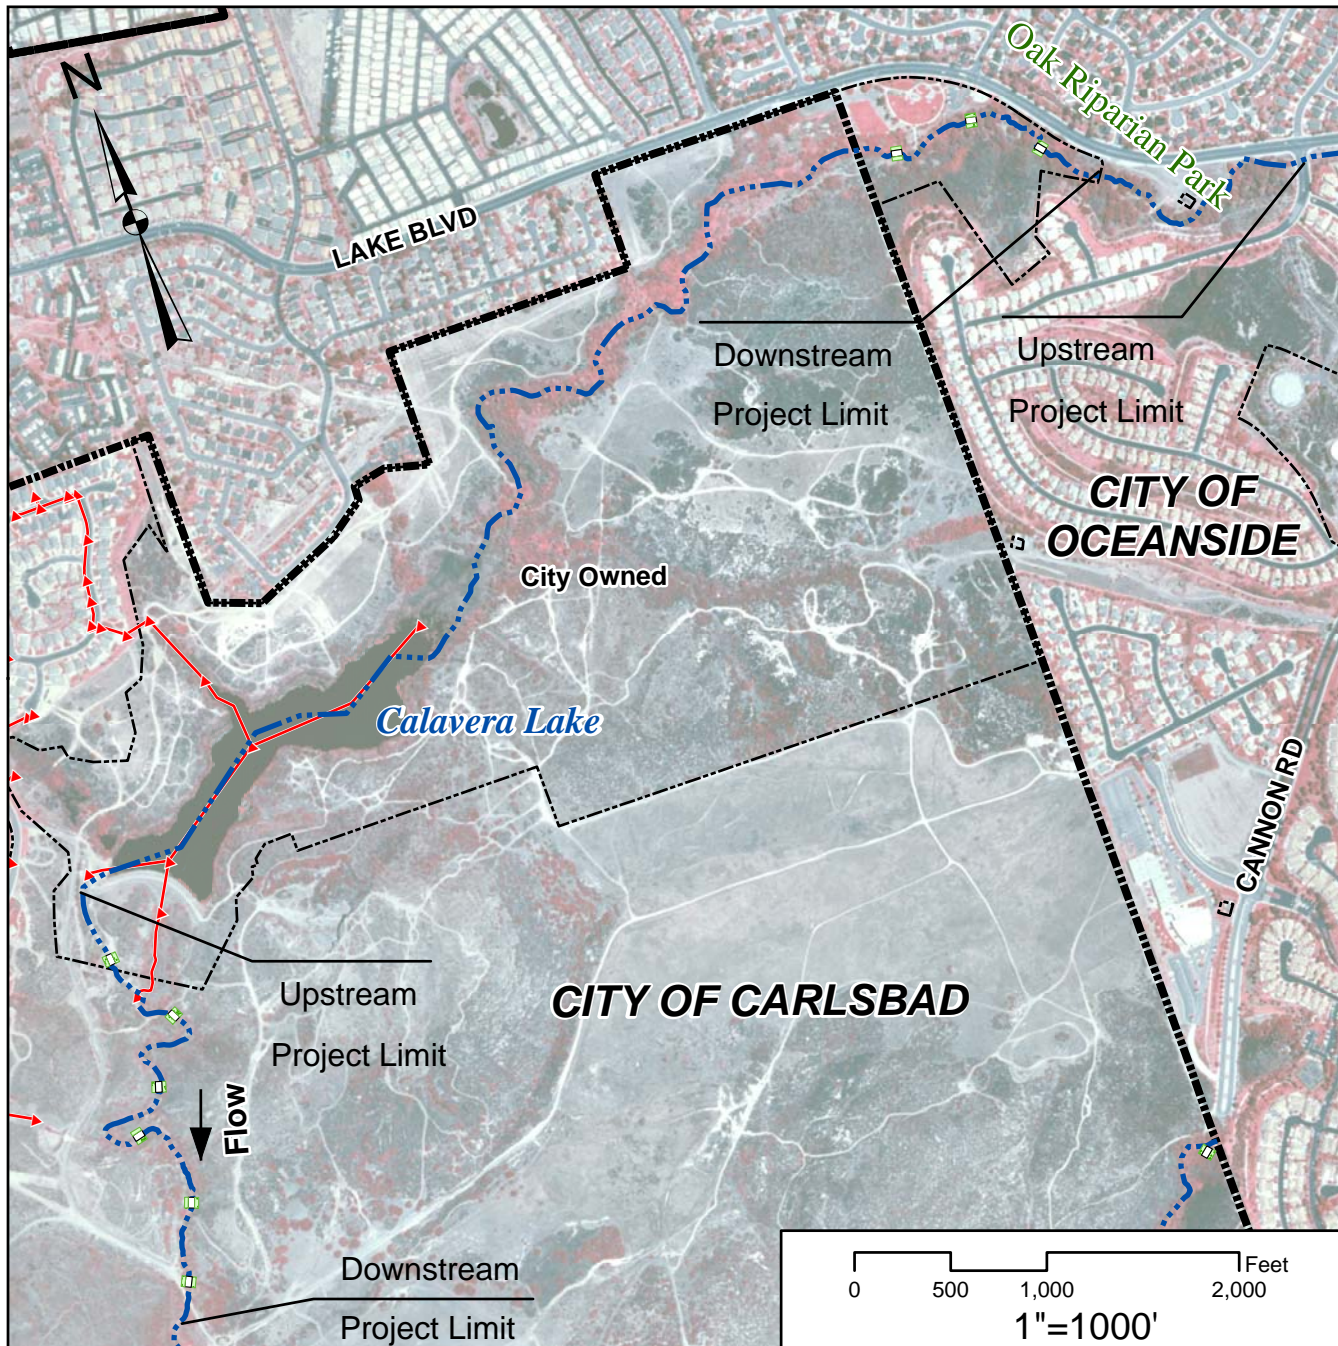
Site #SR-9: Calavera Creek Reach 60

Mass wasting of channel

Regrade banks

Grade stabilizers

Natural settings

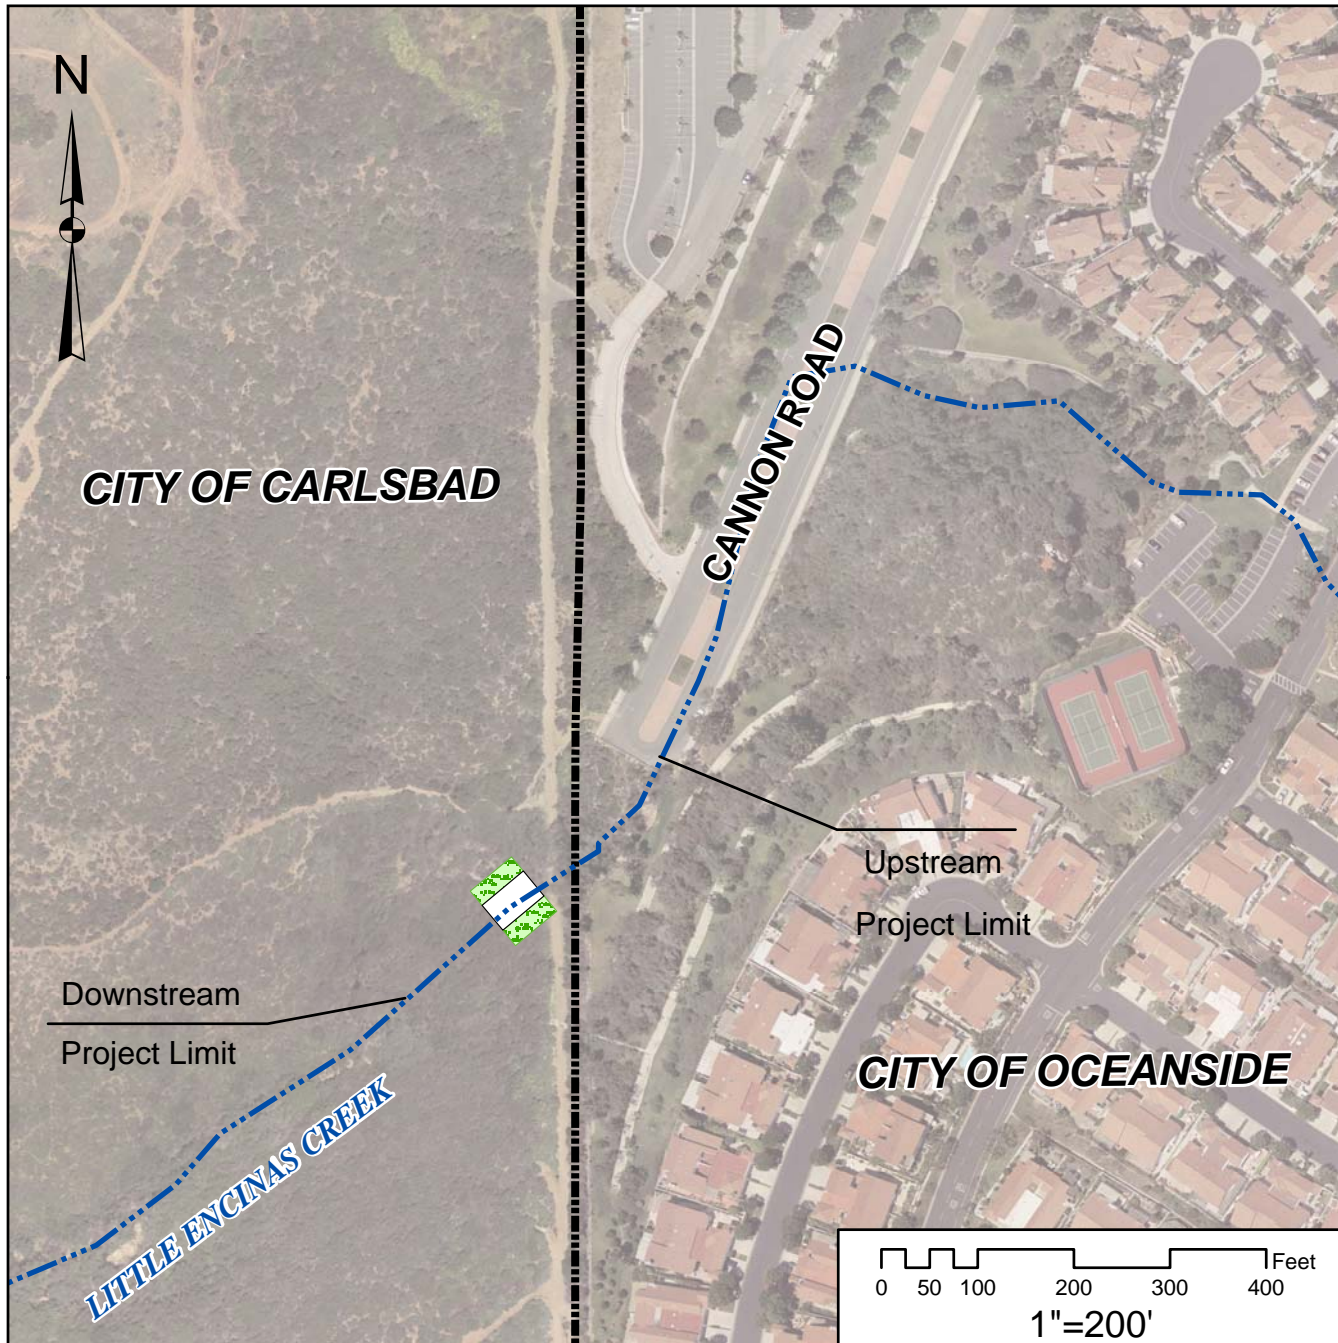
Site #SR-10: Little Encinas Creek Reach 63

Bank failure & Undercutting

Regrade banks

Grade stabilizers

Natural settings

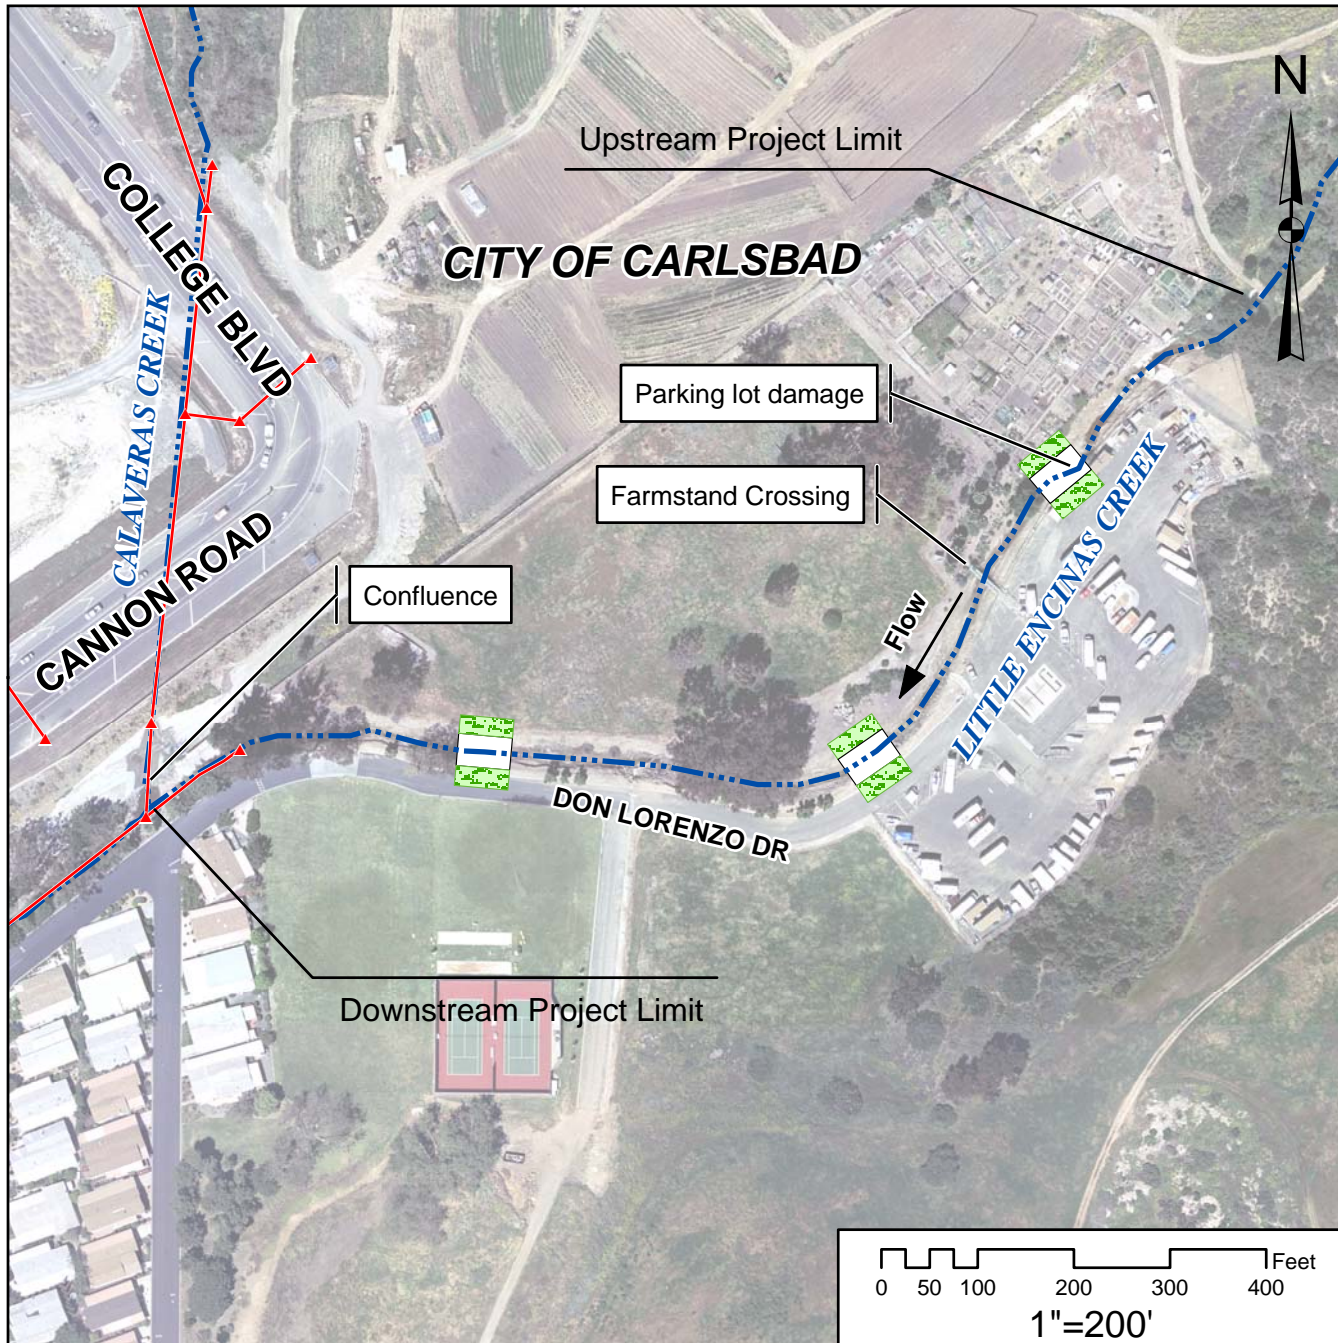
Site #SR-11: Little Encinas Creek Reach 64

- Invert erosion (4') downstream of culvert
- Bank failure
- Damage to adjacent infrastructure
- Intermittent bank protection
- Riprap and geo-fabric slumped into channel

- Regrade bank away from road
- Grade stabilizers
 - Low profile (up to 2' drops)
 - Use rock to match natural settings

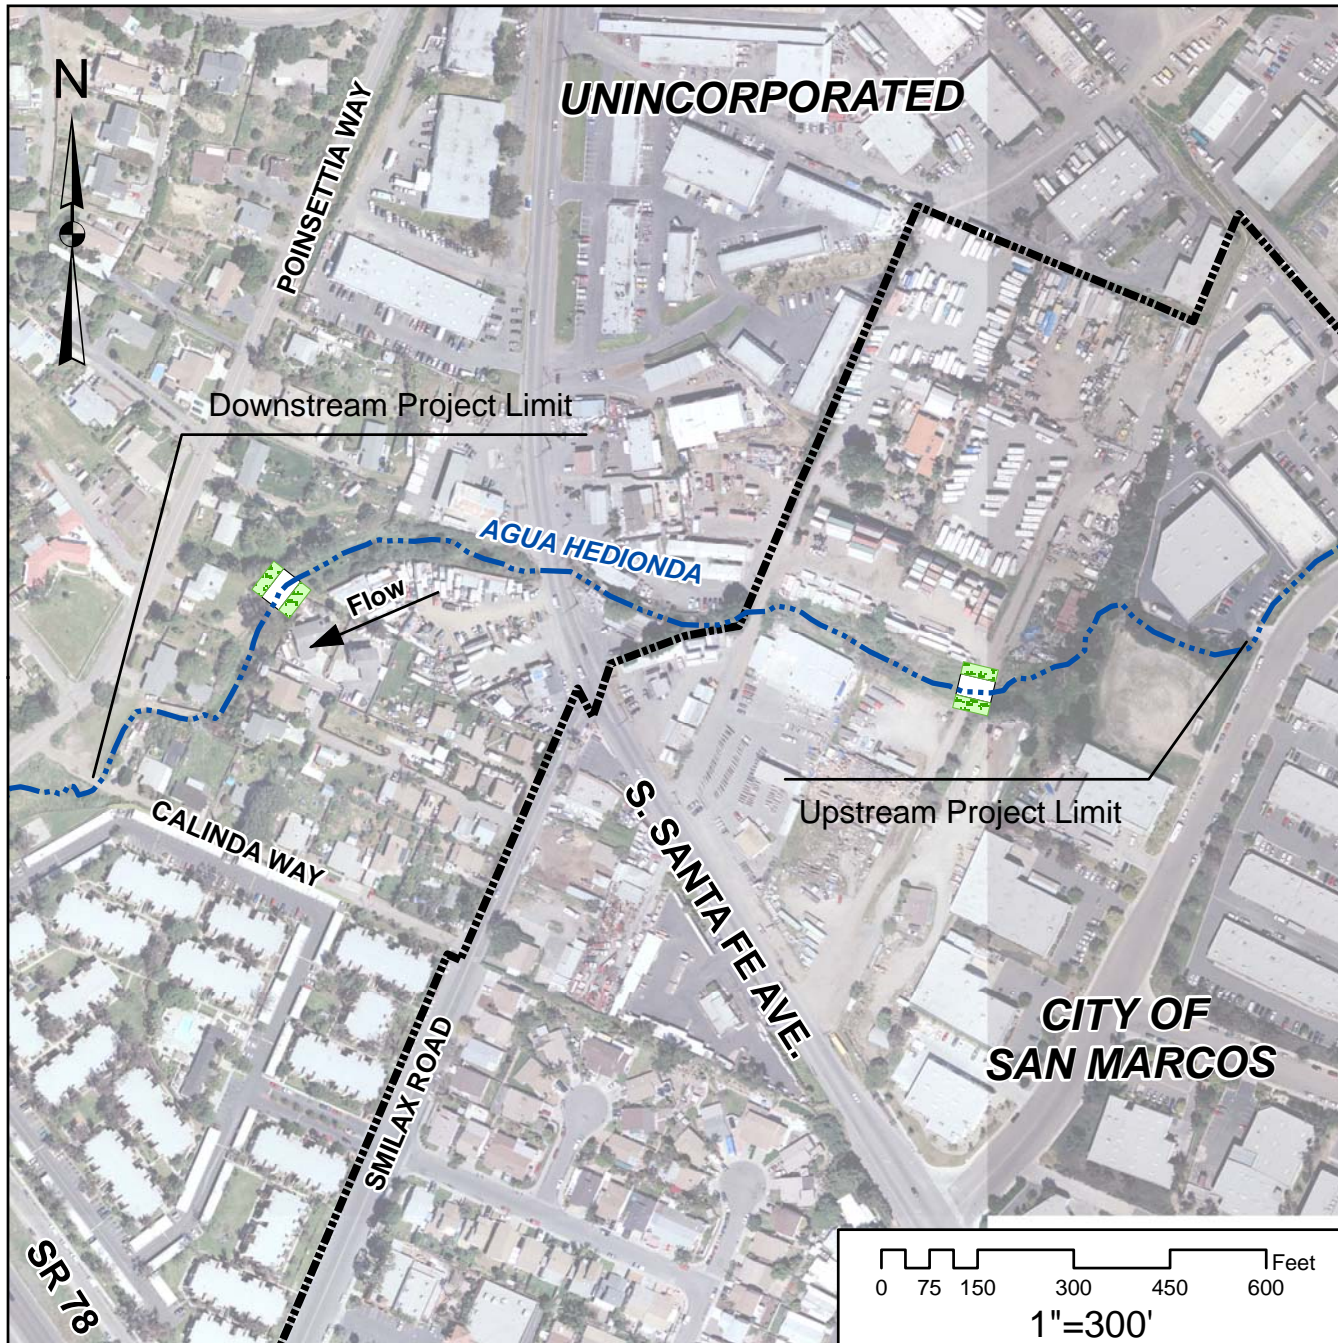
Site #SR-12: Agua Hedionda Reach 4

- Erosion
- Channel confinement
- Adjacent Infrastructure

Grade Stabilizers

- Low profile (up to 2' drops)
- Select locations that do not disturb high value trees
