Appendix C. Stream Restoration Concept Sheets

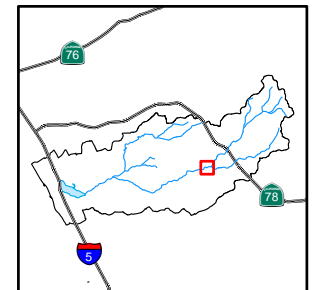
Site #SR-1: Agua Hedionda Reach 9

- Clogged culvert
- Obstructed culvert entrance
- Bank erosion

- Clean culvert
- Regrade culvert entrance area
- Grade Stabilizers

- Low profile (up to 2' drops)
- Select locations that do not disturb high value trees

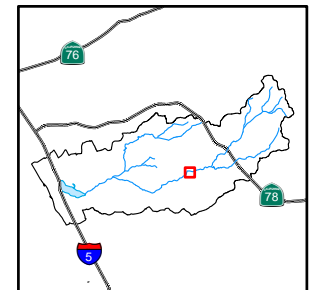
Site #SR-2: Agua Hedionda Reach 14-15

- Erosion along the toe
- Large trees undercut
- Exposed sewer line
- Failing Grade Stabilizer

Grade Stabilizers

- Low profile (up to 2' drops)
- Select locations that do not disturb high value trees

Toe Protection

- At location of imminent failure
- Soil wraps, boulders, rock vanes, willow whips

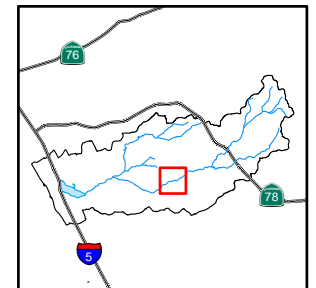
Site #SR-3: Agua Hedionda Reach 17

Moderate to significant bank failure at specific locations

Identification of bedrock controls
Determine if bedrocks allows for significant additional bank failure

Toe Protection (rock) at select locations

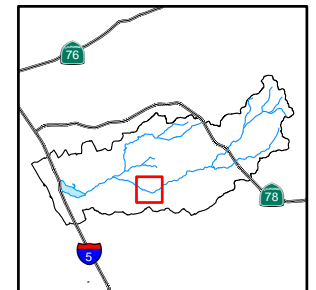
Site #SR-4: Agua Hedionda Reach 18

Moderate to significant bank failure at specific locations

Identification of bedrock controls
Determine if bedrocks allows for significant additional bank failure

Toe Protection (rock) at select locations

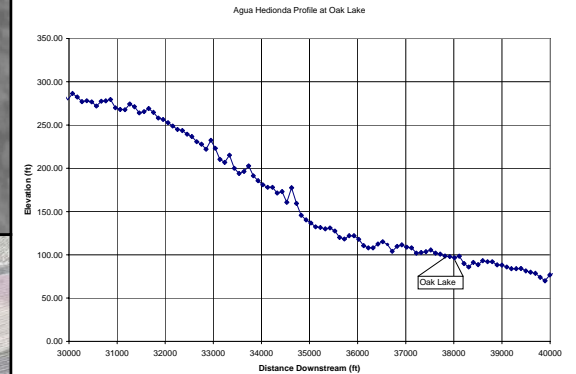
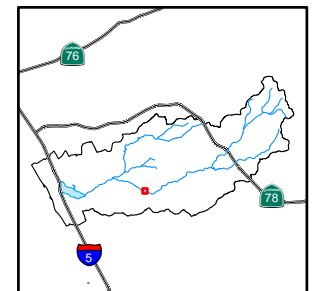
Site #SR-5: Agua Hedionda, Oak Lake

Major Issues
Habitat Feature

Restoration Opportunities
Restore Habitat Feature

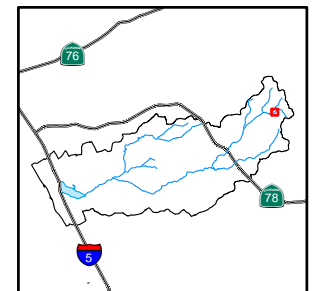
Site #SR-6: Buena Creek Reach 23

- Intermittent bank protection
- Bank erosion to 6' high
- Channel clogged with debris

Grade stabilizers

- Use rock to match natural setting
- Create riffles to mimic existing conditions

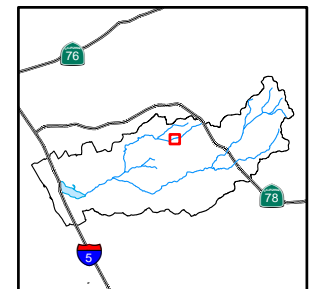
Site #SR-7: Calavera Creek Reach 51

- Channel severely restricted
- No riparian area
- Likely water quality impact from adjacent agriculture

- Purchase adjacent land
 - Widen channel
 - Establish Riparian buffer
- Educational Opportunities
 - Connect proposed shopping center to river

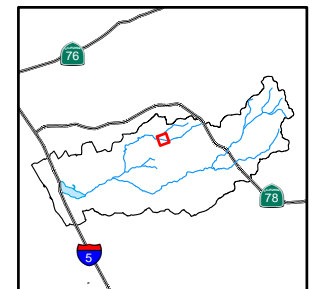
Site #SR-8: Calavera Creek Reach 56A

- Erosion along the toe
- Widening Channel
- Adjacent infrastructure (road and property wall)
- Failed grade stabilizers (sand bags)

Grade Stabilizers

- Low profile (up to 2' drops)
- Use rock to match natural settings

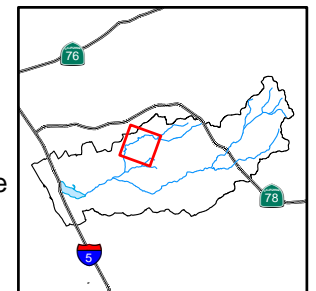
Site #SR-9: Calavera Creek Reach 60

Mass wasting of channel

Regrade banks

Grade stabilizers

Natural settings

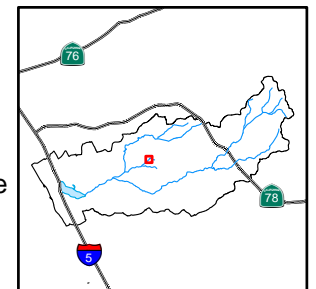
Site #SR-10: Little Encinas Creek Reach 63

Bank failure & Undercutting

Regrade banks

Grade stabilizers

Natural settings

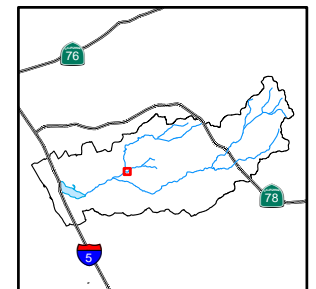
Site #SR-11: Little Encinas Creek Reach 64

- Invert erosion (4') downstream of culvert
- Bank failure
- Damage to adjacent infrastructure
- Intermittent bank protection
- Riprap and geo-fabric slumped into channel

- Regrade bank away from road
- Grade stabilizers
 - Low profile (up to 2' drops)
 - Use rock to match natural settings

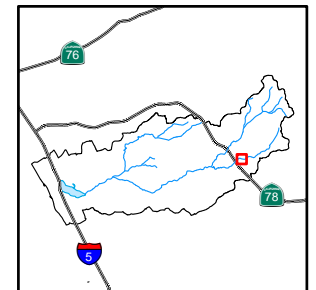
Site #SR-12: Agua Hedionda Reach 4

- Erosion
- Channel confinement
- Adjacent Infrastructure

Grade Stabilizers

- Low profile (up to 2' drops)
- Select locations that do not disturb high value trees
